## Restart IP Service Feature procedure for the 9070 series.

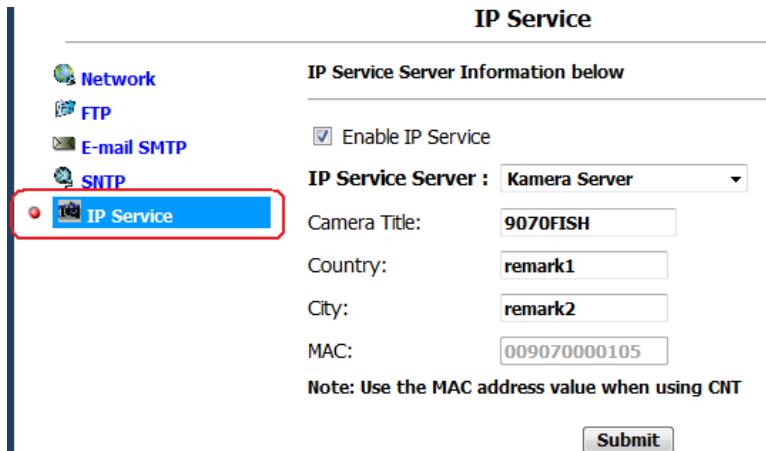
Due to current updates to our servers and our internet services, we have made some changes that will require you to restart the IP service feature for it to work properly.

- 2.) Then on the left menu side select the IP service button link

- 3.) If the IP service is enabled, please disable the function first and hit submit.
- 4.) Then click on the IP service link again and Enable the device and hit submit.
- 5.) Once enabled, click on the System button located on the bottom of the screen.
